## NDRMF Completes Restoration of the **SURJANI COMPLEX BUND, DISTRICT SUJAWAL SINDH**

**5.6 kilometer river training structures has been rehabilitated to protect communities along the Indus River**

NDRMF funded project: Rehabilitation, Raising and Strengthening of Spurs along Surjani Complex Bund, Village Lower Pinyari, UC Pinyari, district Sujawal, Hyderabad Division, Sindh

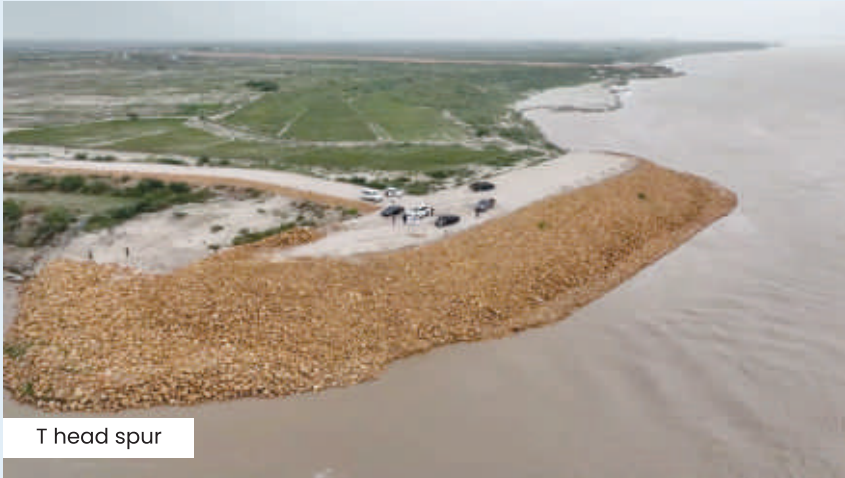
T head spur

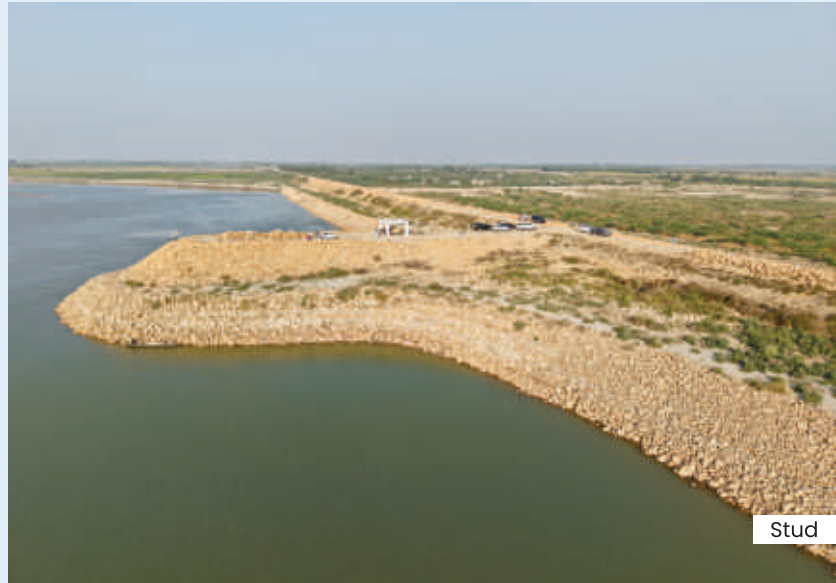
The intervention was designed to stabilize the riverbank, strengthen vulnerable sections of the embankment and divert floodwaters away from populated areas, thereby improving the bund's ability to withstand future flood events
